TECHNICAL REPORT M-86/17
September 1986
Underground Distribution Systems

Corrosion of Aluminum Jackets on Aboveground Heat Distribution Systems

by
Kirk E. Cooper
Ellen G. Segan

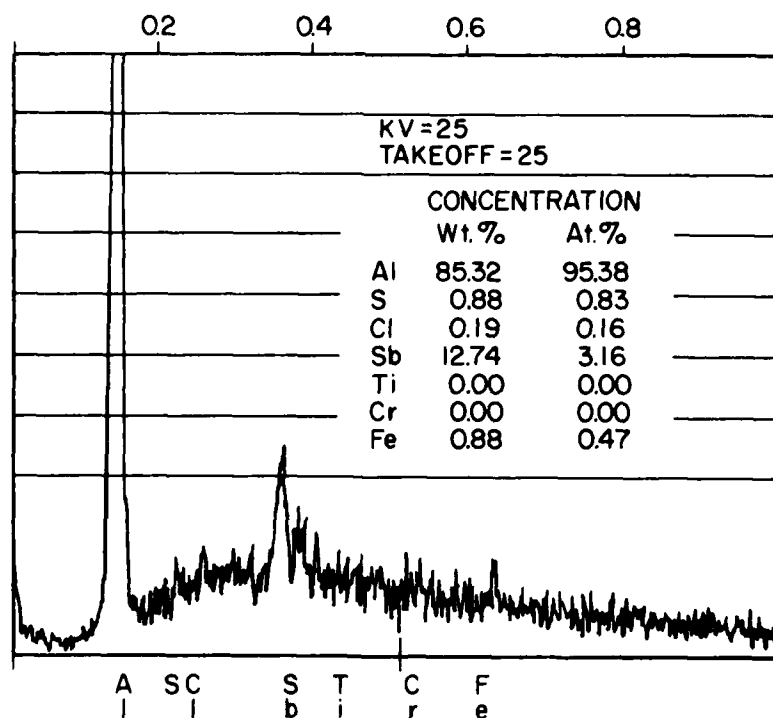
Figure 11. EDAX spot spectra. a: EDAX spot spectrum (1000 X) on the white deposit shown in Figure 10a. Elemental concentrations are shown in the inset. b: Spectrum (1000 X) on corrosion product around the pit shown in Figure 10b. The peak marked as antimony may be calcium.
